Technical Note N-1032

EFFECTIVENESS OF ZINC COATING ON REINFORCING STEEL IN CONCRETE
EXPOSED TO A MARINE ENVIRONMENT

Donald F. Griffin

↓
NAVAL CIVIL ENGINEERING LABORATORY
Port Hueneme, California 93041

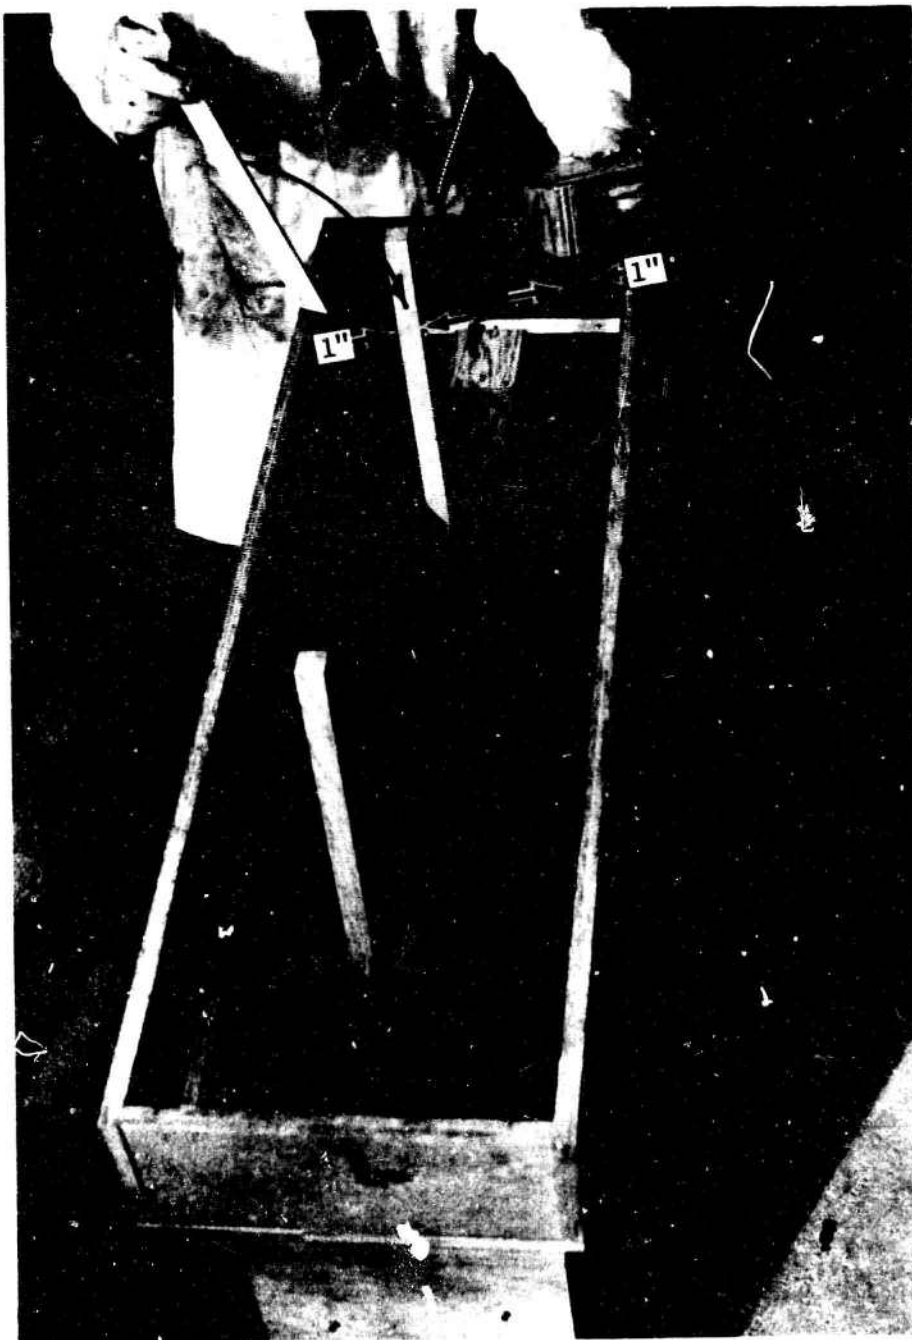
Figure 5. Wooden spacers in place for holding steel grid. Concrete disks are permanent vertical spacers.

While filling the forms with concrete, the steel grids were held securely in place with spacers as shown in Figure 5. The wooden spacers were continually withdrawn to the level of the fresh concrete; the spacers made of concrete were left in place. After a wall was half-filled with fresh concrete, the form vibrators were moved from a lower

position to an upper position on the form. The concrete disks shown in Figure 5 were of the same concrete design as the corresponding wall. The disks were etched in hydrochloric acid and rinsed in fresh water prior to use.

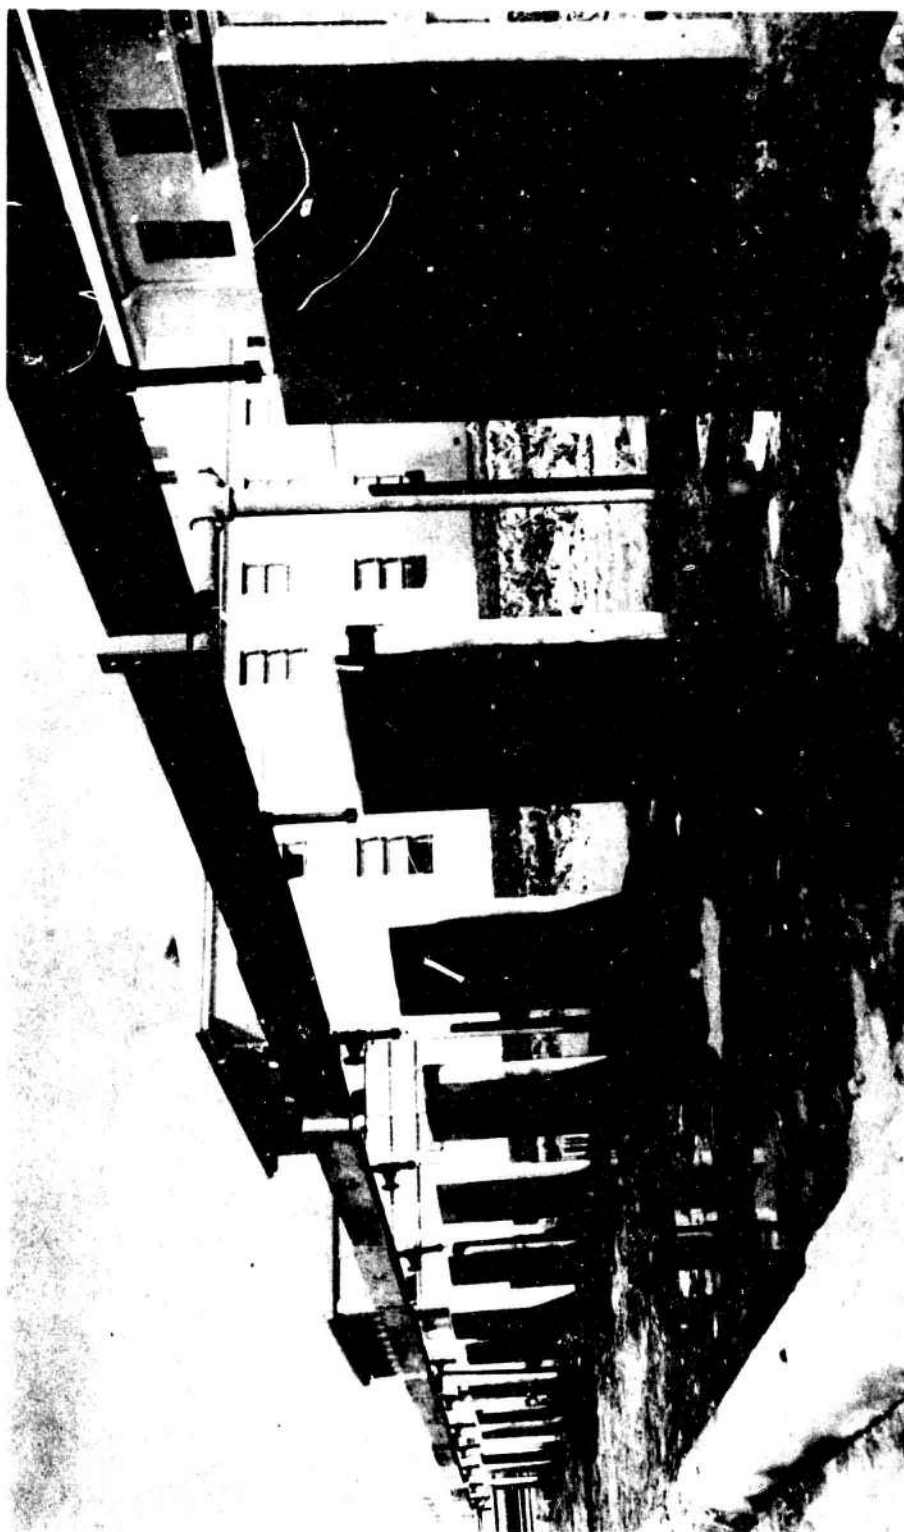
Figure 7. Overall view of walls and sea water spray system.

At 28 days age, each wall and corresponding field specimens were removed from the fog room and transferred to a field site. Each wall was carefully inverted so it was right side up. By means of rope slings, the walls were lifted as shown in Figure 6 and then lowered onto a prepared sand bed. The ropes were pulled from beneath the walls with very little disturbance of the soil and then the wood forms were removed. The walls were oriented so that the horizontal bars in the steel grids were toward the face receiving sea water spray; the vertical bars were toward the opposite face. An overall view of the walls and sea water spray system is shown in Figure 7.

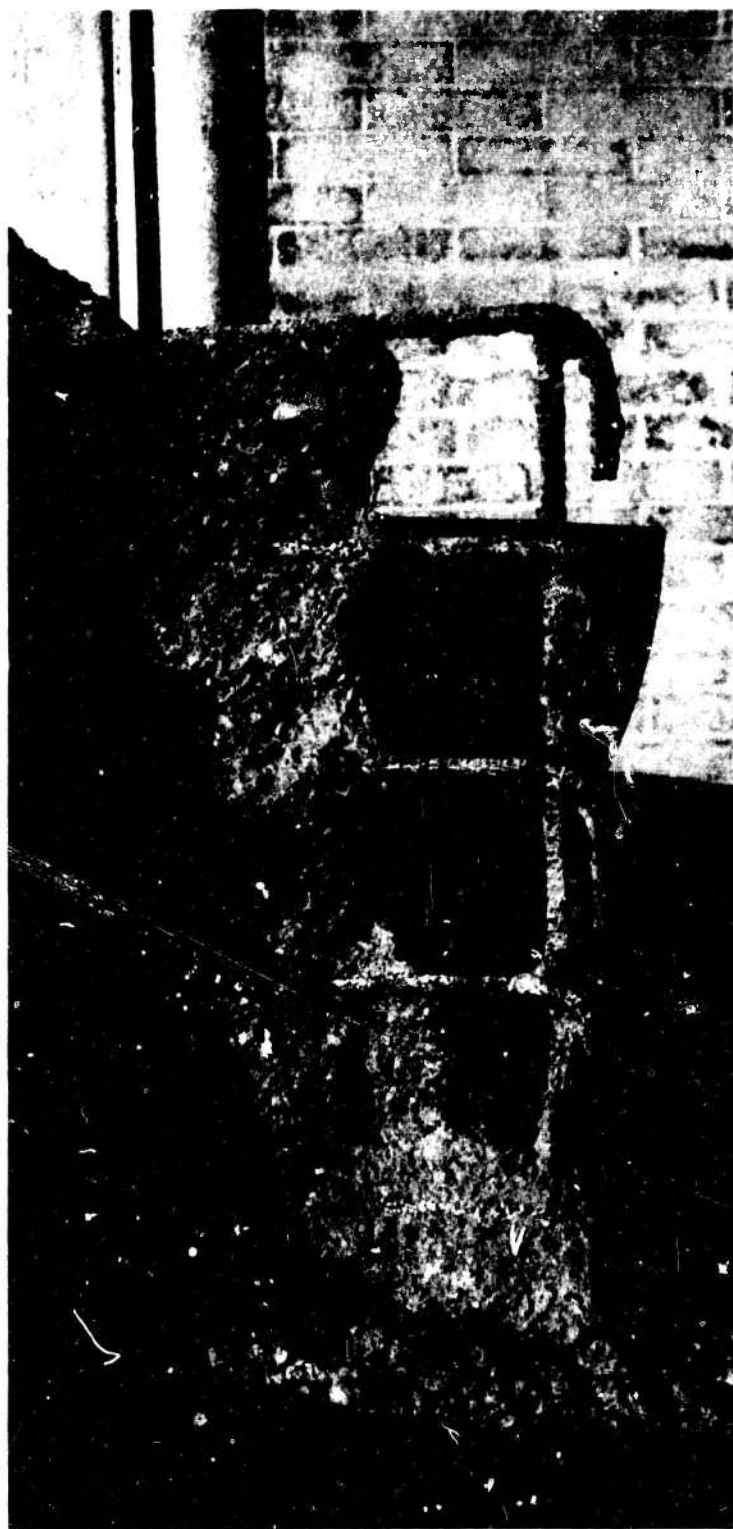
Figure 11. Ferrous oxide on zinc-coated steel bars - east end of Wall 101.

Figure 10 shows cracking typical of the kind occurring on the east and west end faces. The dark areas in Figure 10 are brown stains of ferrous oxide that had migrated from the reinforcing bars. Figure 11 shows the source of the rust.

Concrete was removed from the steel grid of wall 101 on 11 December 1968. The steel of this wall was zinc coated and the contact welds and the bends in the horizontal bars had been touched up with zinc-enriched paint. Every horizontal bar showed white corrosion products of zinc throughout the entire length. In addition each horizontal bar had positive showings of red rust scattered over the entire length. The two vertical bars, one on either side of the grid, were affected similarly to the horizontal bars. The four inner vertical bars had white corrosion products adjacent to the weld joints for a distance of about 1.5 inches on either side of the joint. There was no evidence of red rust on these four inner bars. The portions of the horizontal bars that were bent to the vertical position were the most severely corroded. On the east end of the wall, the red rust was very heavy.

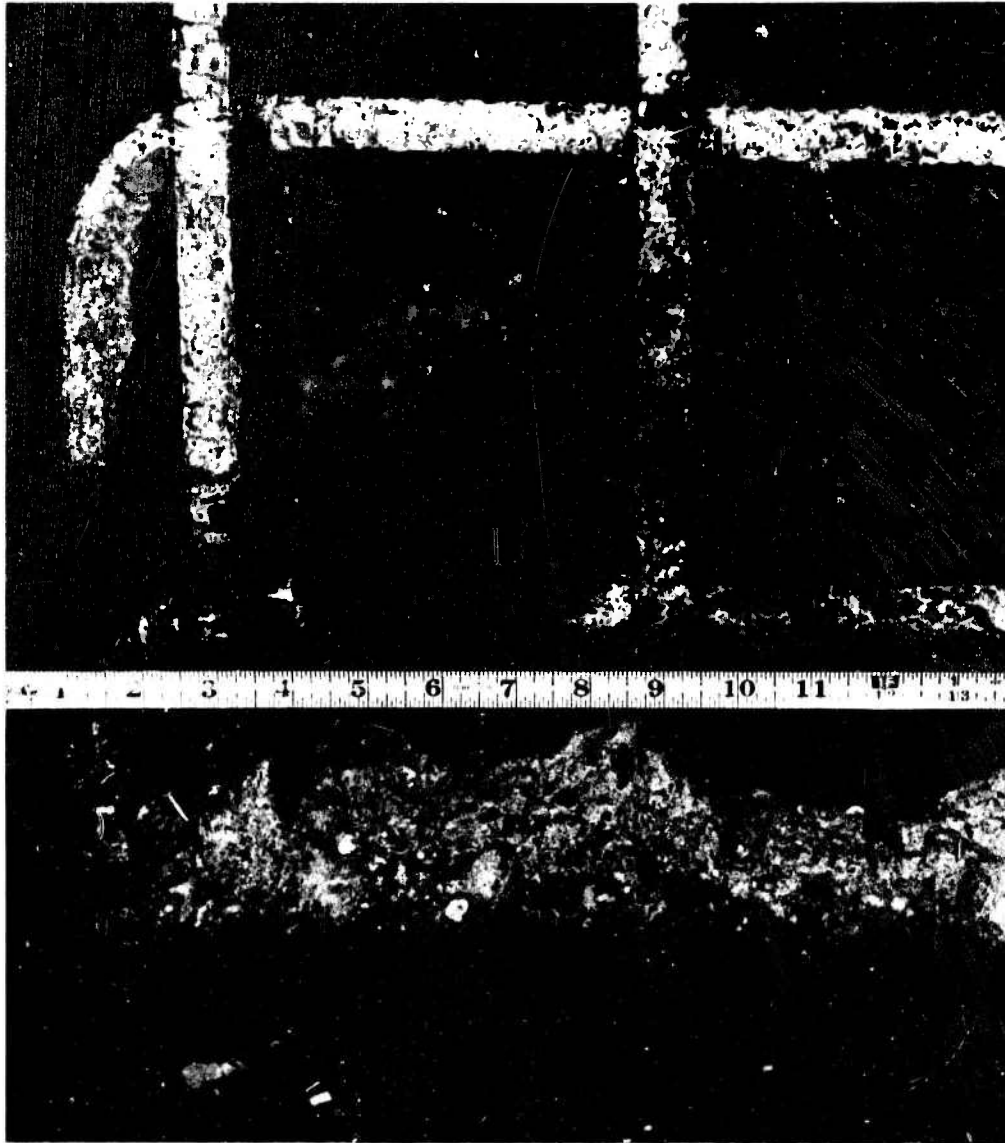
Figure 13. Steel exposed for Wall 103. Dark areas are ferrous oxide. Lower bar is opposite horizontal crack in Figure 12.

Figure 12 shows two types of cracking in the two larger faces of the walls. The crack in the upper right hand corner is typical of random cracking adjacent to east or west edges. No continuous and more or less straight vertical cracks have occurred on the north or south faces. The lower horizontal crack is not uncommon. It is directly opposite the lower horizontal steel bar of Figure 13.

On 20 January 1969 the concrete from wall 103 was removed from its steel grid. This grid was treated identical to that of wall 101 except the horizontal and vertical bars were tied and insulated one from another and were not welded. The exposed steel of wall 103 had the same general appearance as that of wall 101. All horizontal bars were coated with white corrosion products of zinc. White corrosion products on vertical bars were less extensive and more scattered than on horizontal bars; however, all vertical bars were affected. All bars (horizontal and vertical) had scattered red rust spots; however, the lower two horizontal bars contained the most red rust. Of these two bars, the lower bar had the most red rust. Where the horizontal bars were turned down vertically, there was no more red rust than for other areas of the bars, except for the lower bar on the west end; here, the red rust was heavier but not near as heavy as for wall 101.
